**KOMITE NASIONAL KESELAMATAN TRANSPORTASI
REPUBLIC OF INDONESIA**

KNKT.18.10.35.04

Aircraft Accident Investigation Report

**PT. Lion Mentari Airlines
Boeing 737-8 (MAX); PK-LQP
Tanjung Karawang, West Java
Republic of Indonesia
29 October 2018**

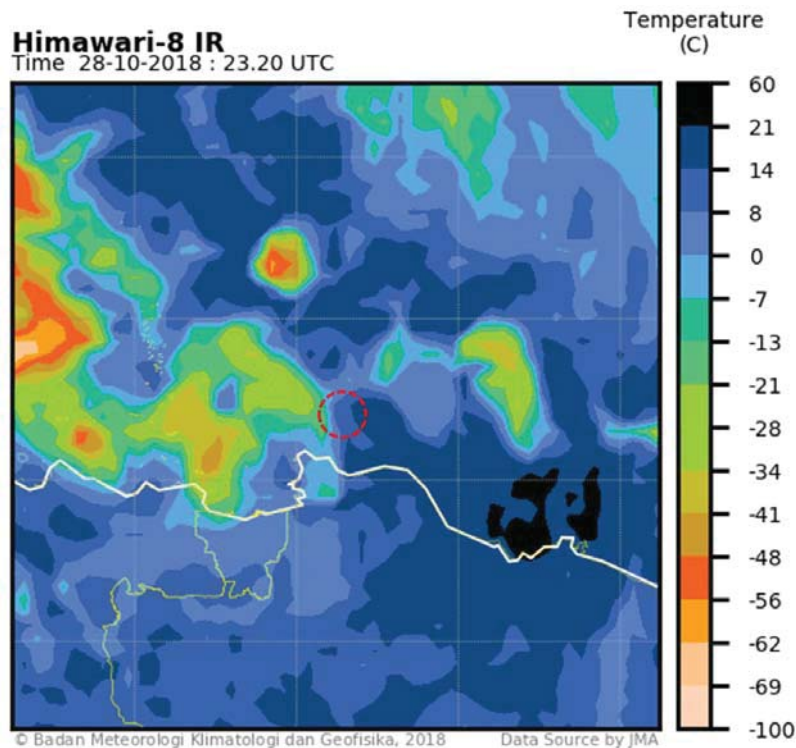
Figure 1: Enhanced infrared satellite image at 2320 UTC (0620 LT)

The *Badan Meteorologi Klimatologi dan Geofisika* (BMKG – Bureau of Meteorology, Climatology and Geophysics) provided enhanced infrared satellite images. The enhanced infrared satellite images at 2320 UTC (0620 LT) up to 2330 UTC (0630 LT) indicated that the temperature at the accident site (red circle) was from 0 up to 8°C.
